Army Lodging Wellness Recommendation

Final Submittal - Carlisle Barracks

February 20, 2004

Section 1 Wellness Recommendation

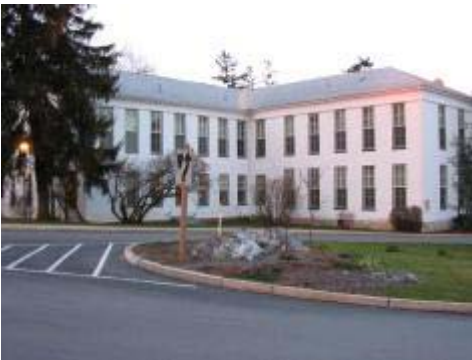
Building 07

Building 7, constructed in 1888, is a historical 2-story wood structure which received major renovations in 1988 and in 2001. The building has 10 existing standard rooms and 4 family suites. Although these facilities were recently renovated, they do not meet Lodging size requirements or provide appropriate support spaces and cannot be reconfigured without significant reconstruction. To renovate Building 7 to the new standards and configuration will exceed 50% of the replacement cost.

It should be noted that this structure is historical and some Army Lodging functional requirements indicated in the report would require clearance from the SHPO or through Army Alternate Procedures; therefore, some of the requirements may need modification, in which case the prices for implementation may vary from the cost models applied.

Our recommendation is to remove building 7 from the Lodging inventory, allowing the installation to determine an alternate use for this facility. This facility will be removed from the Carlisle Barracks Wellness Solution and Lodging Master Plan.

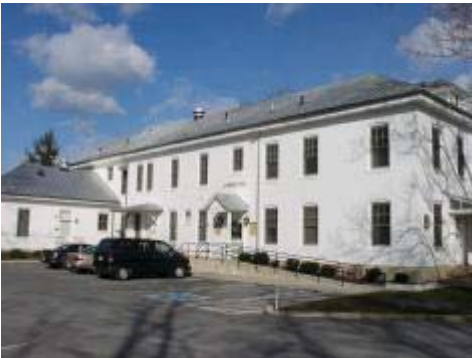
Building 36

Building 36, constructed in 1908, is a historic 2-story wood structure which received a major renovation in 1997. This Main Lodging facility has 15 existing standard rooms and 4 family suites. The building is in good condition and meets the majority of the Army functional standards, but has some room size and corridor width constraints based on original configuration and is missing some of the Main Lodging spaces. Based on age of the structure, however, we do not recommend significant renovations to the public spaces and/or back-of-the-house space to meet functional criteria.

It should be noted that this structure is historical and some Army Lodging functional requirements indicated in the report would require clearance from the SHPO or through Army Alternate Procedures; therefore, some of the requirements may need modification, in which case the prices for implementation may vary from the cost models applied.

The Wellness Recommendation replaces the Main Lodging support spaces in building 36 to the new facility, and continues the use of this building as a secondary facility over the next 15-20 years with normal maintenance.

Our recommendation is to retain building 36 in the Carlisle Barracks Lodging inventory. This facility will remain in the Carlisle Barracks Wellness Solution and Lodging Master Plan.

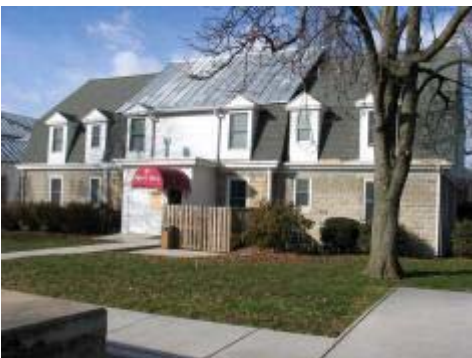
Building 37

Building 37, constructed in 1908, is a historic 2-story wood structure which received a major renovation in 1998. This building has 10 existing standard room and 2 family suites. The building is in good condition and meets the majority of the Army functional standards, but has some room size and corridor width constraints based on original configuration. Based on age of the structure, however, we do not recommend significant renovations to the public spaces and/or back-of-the-house space to meet functional criteria.

It should be noted that this structure is historical and some Army Lodging functional requirements indicated in the report would require clearance from the SHPO or through Army Alternate Procedures; therefore, some of the requirements may need modification, in which case the prices for implementation may vary from the cost models applied.
